TETRA TECH BAS

OYSTER POINT LANDFILL

SITE INUNDATION IN 2050 - 12" SEA LEVEL RISE

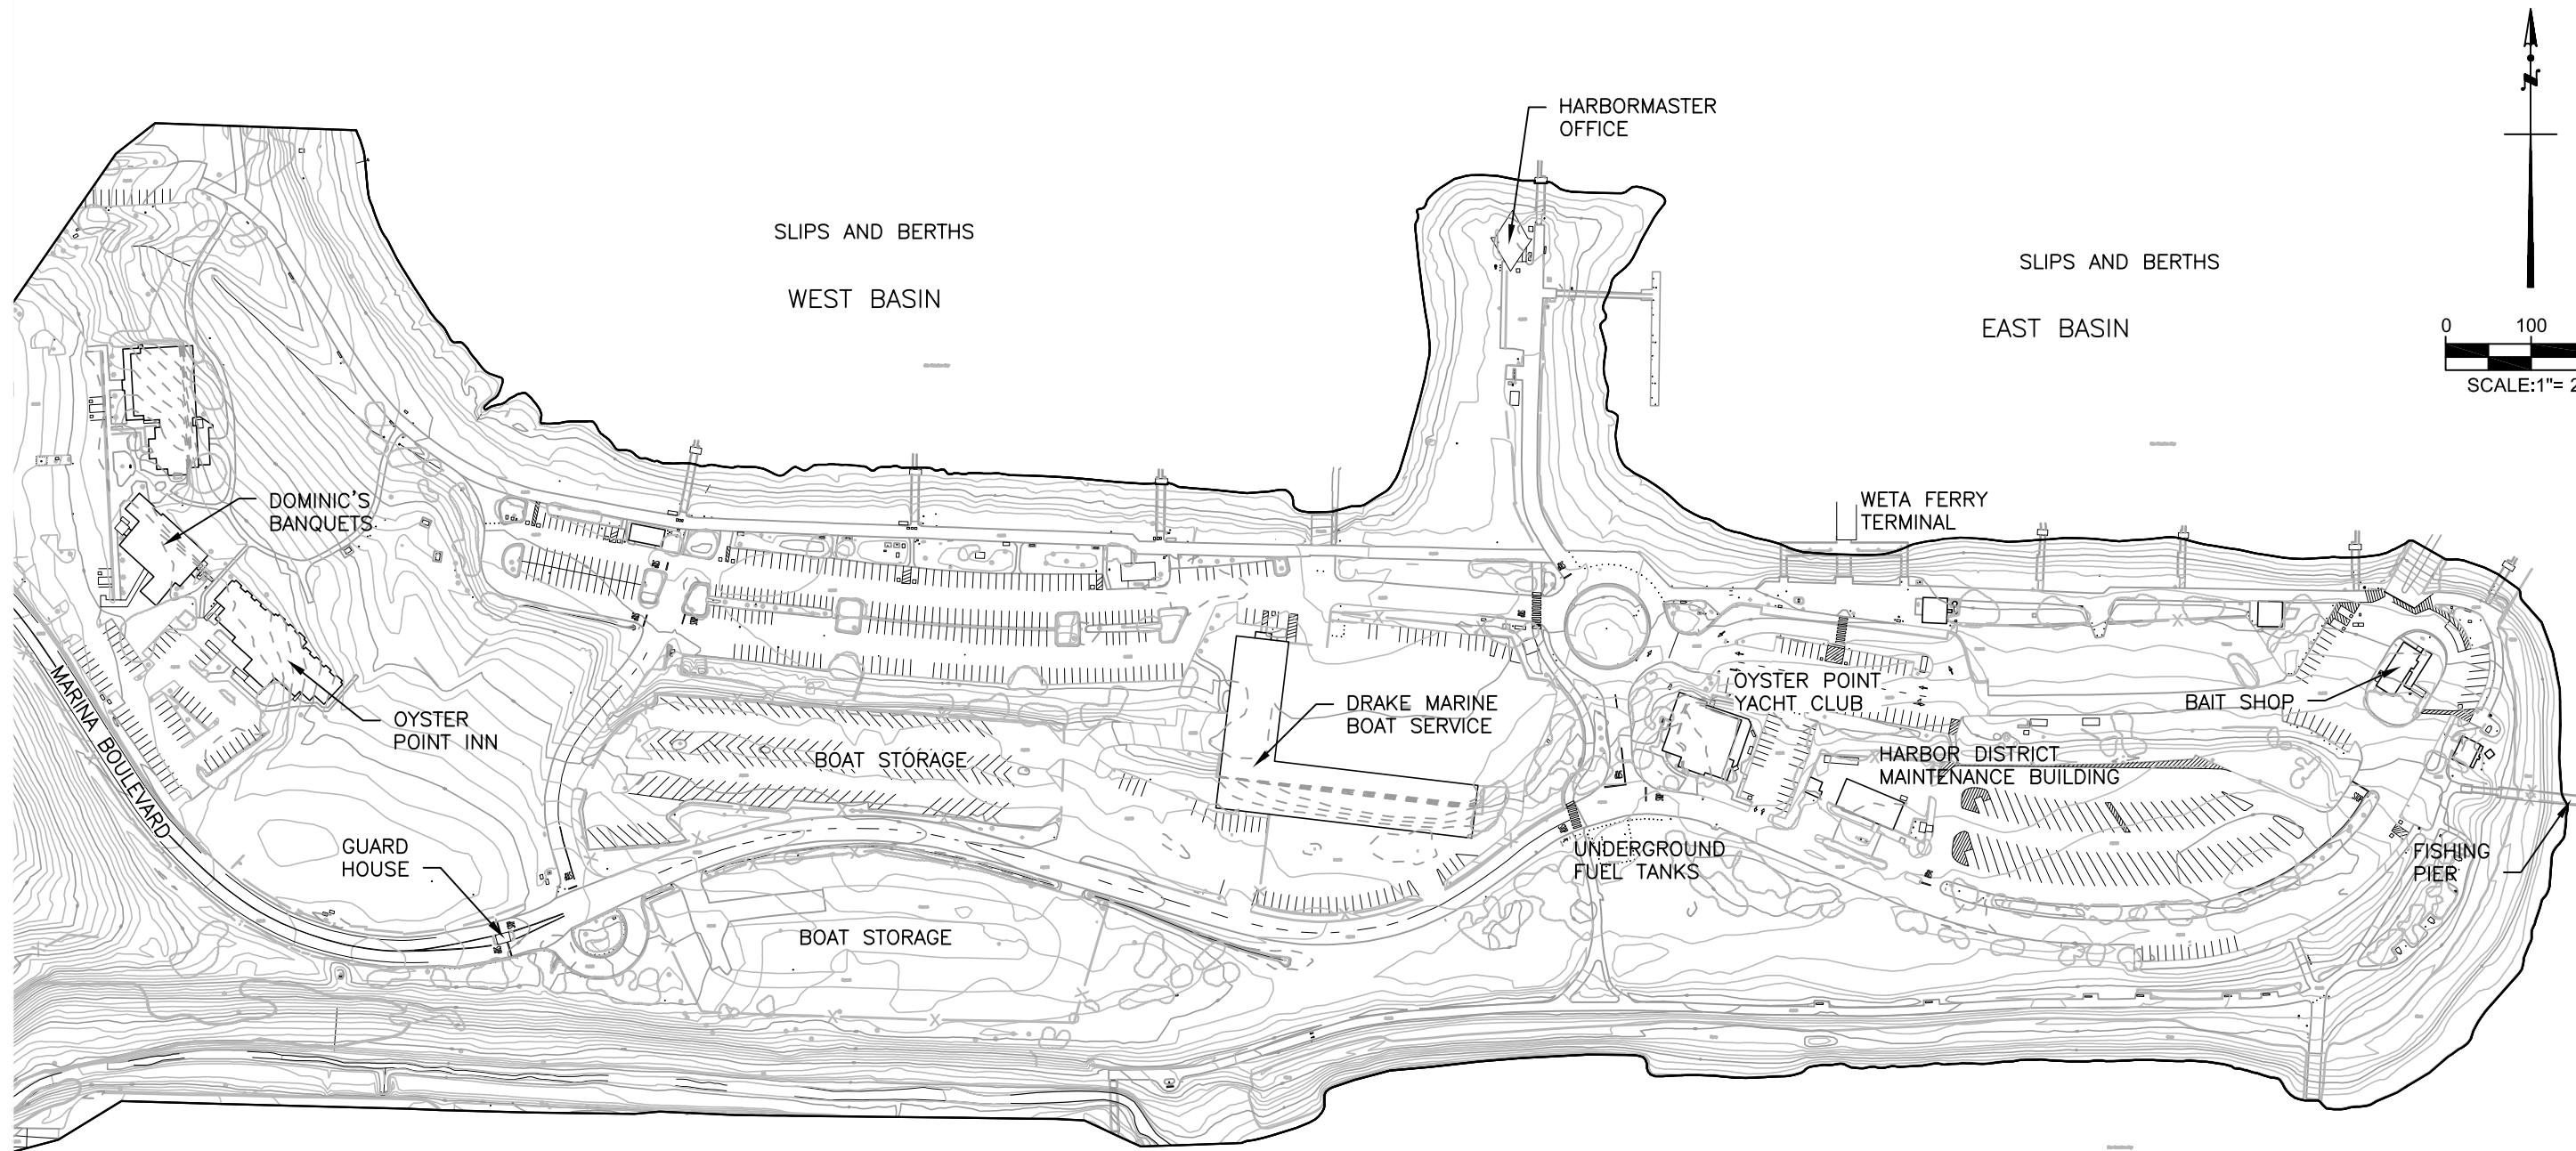
FIGURE 6

SITE MAP

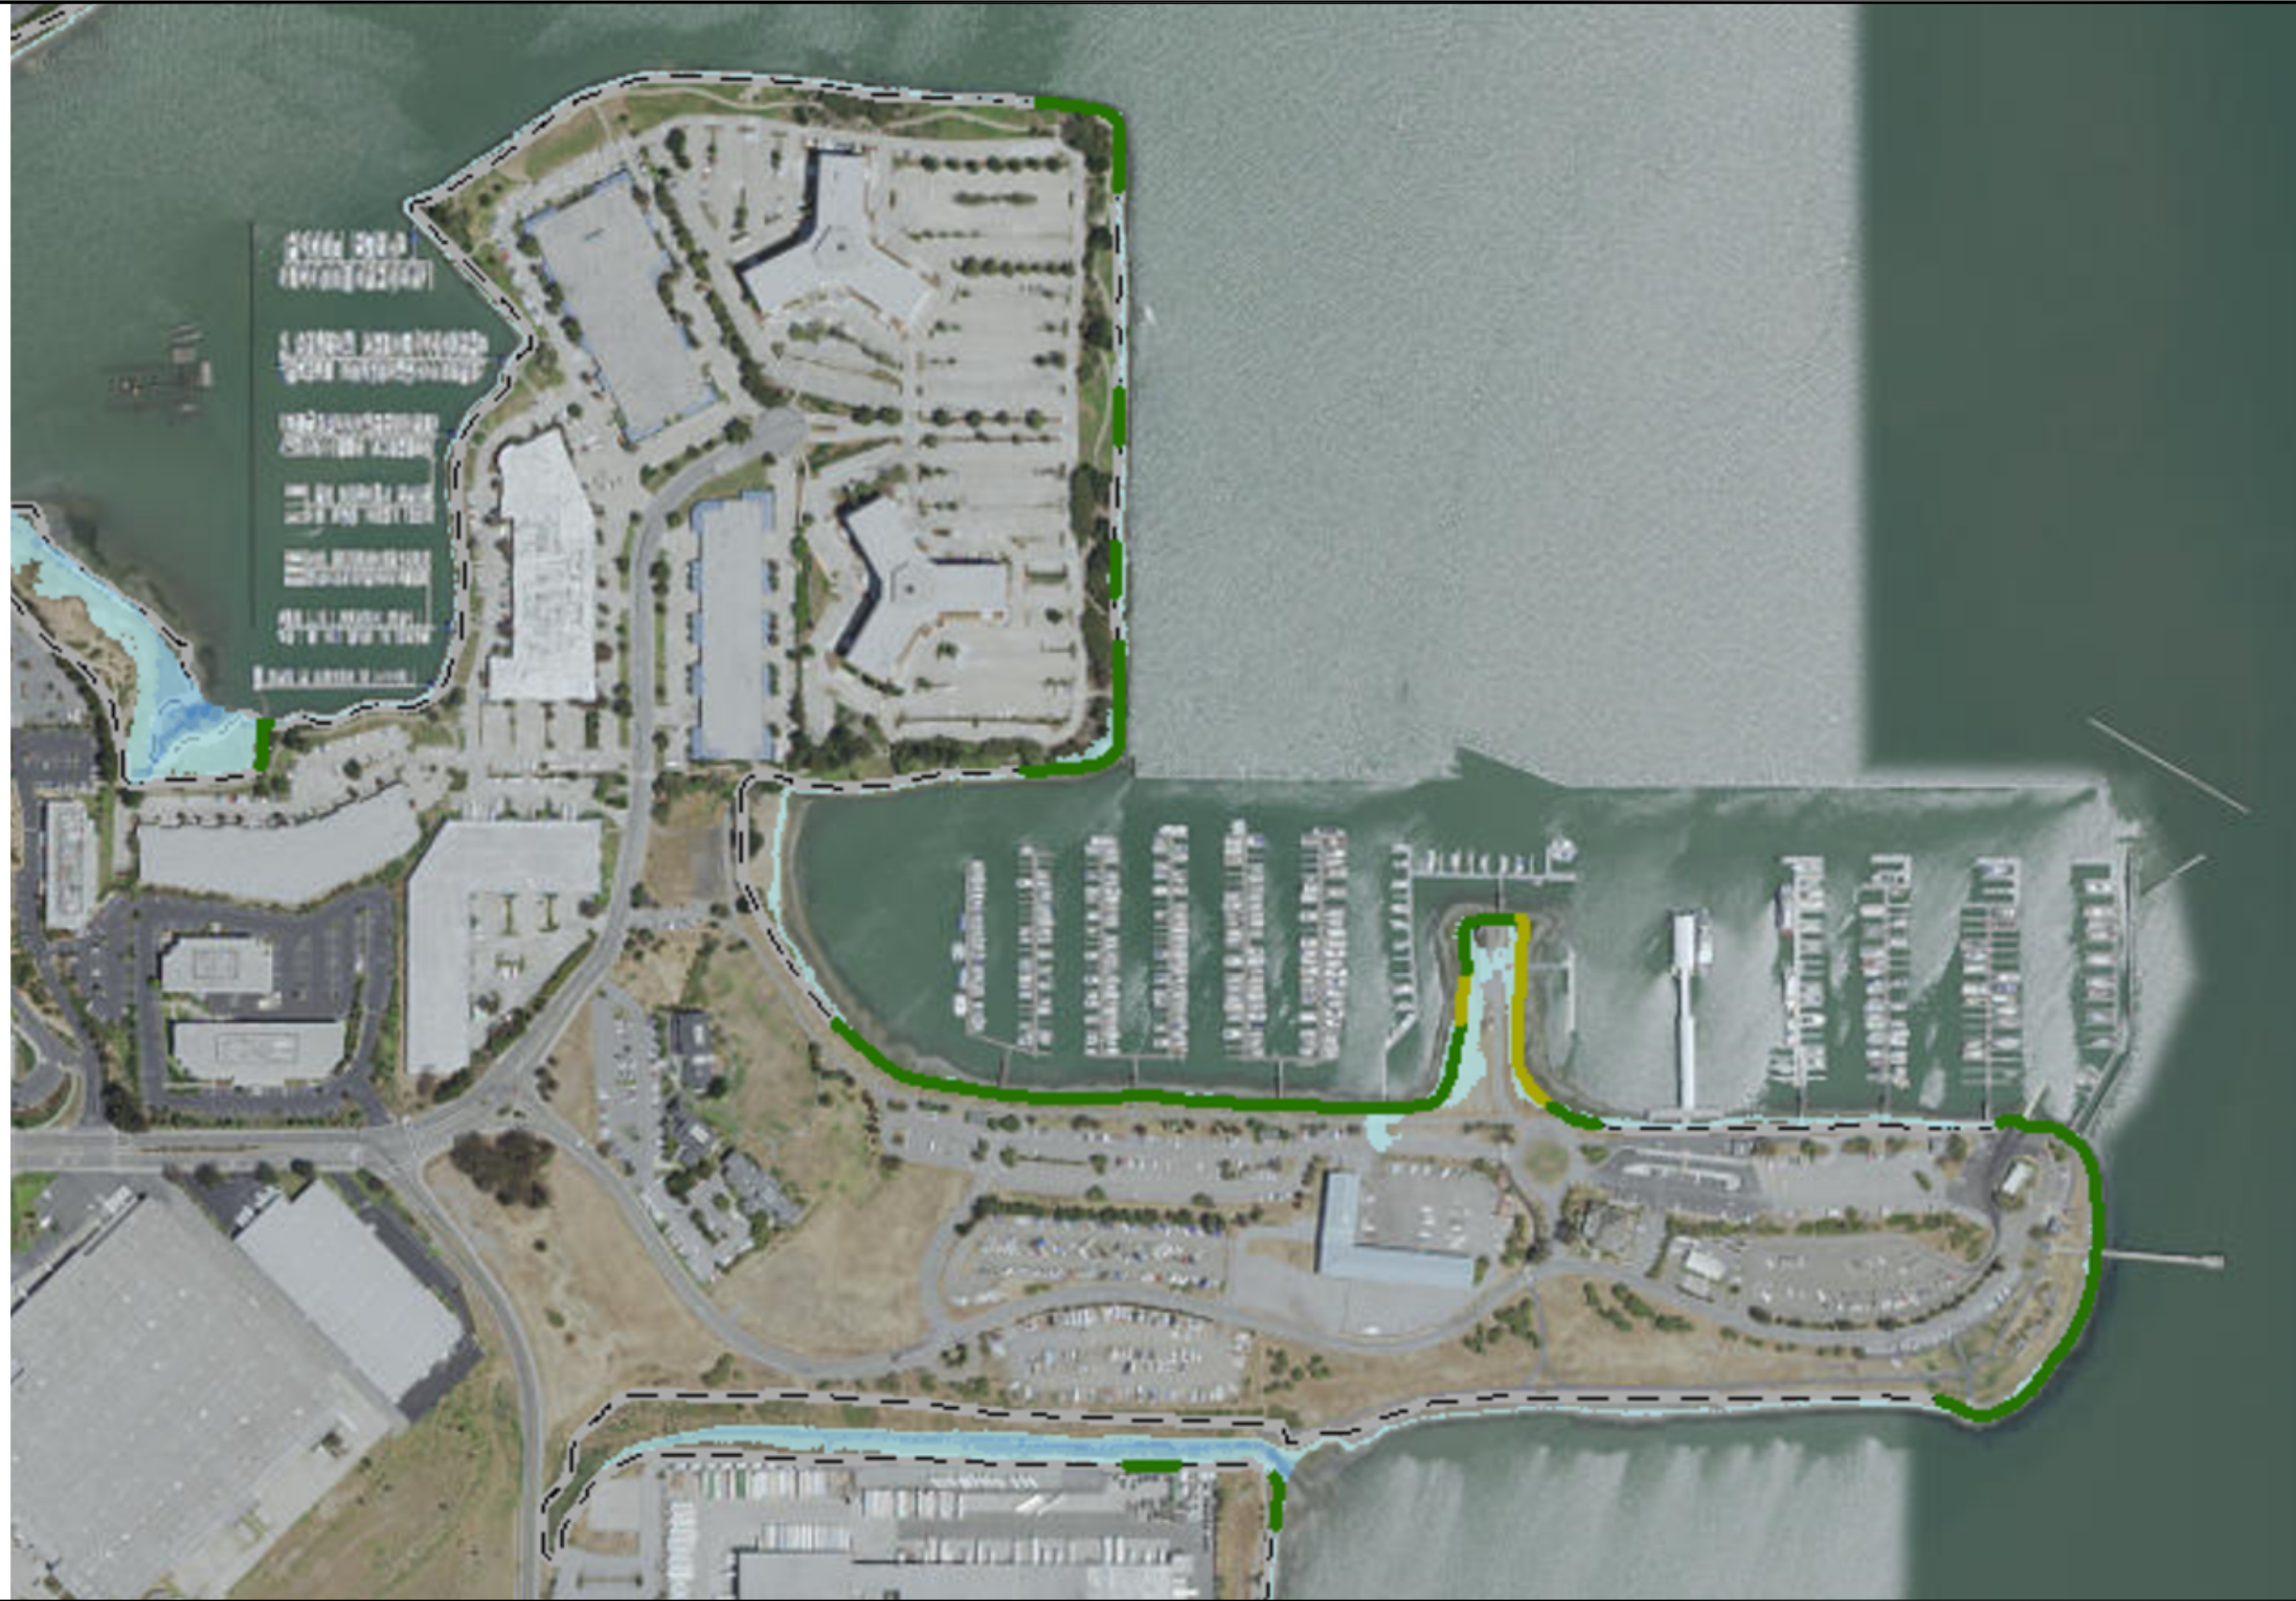
FIGURE 7

MHHW + 12" SLR
Shoreline
Overtopping
Potential Depth
(Feet)

MHHW + 12" Sea
Level Rise Depth
(Feet)

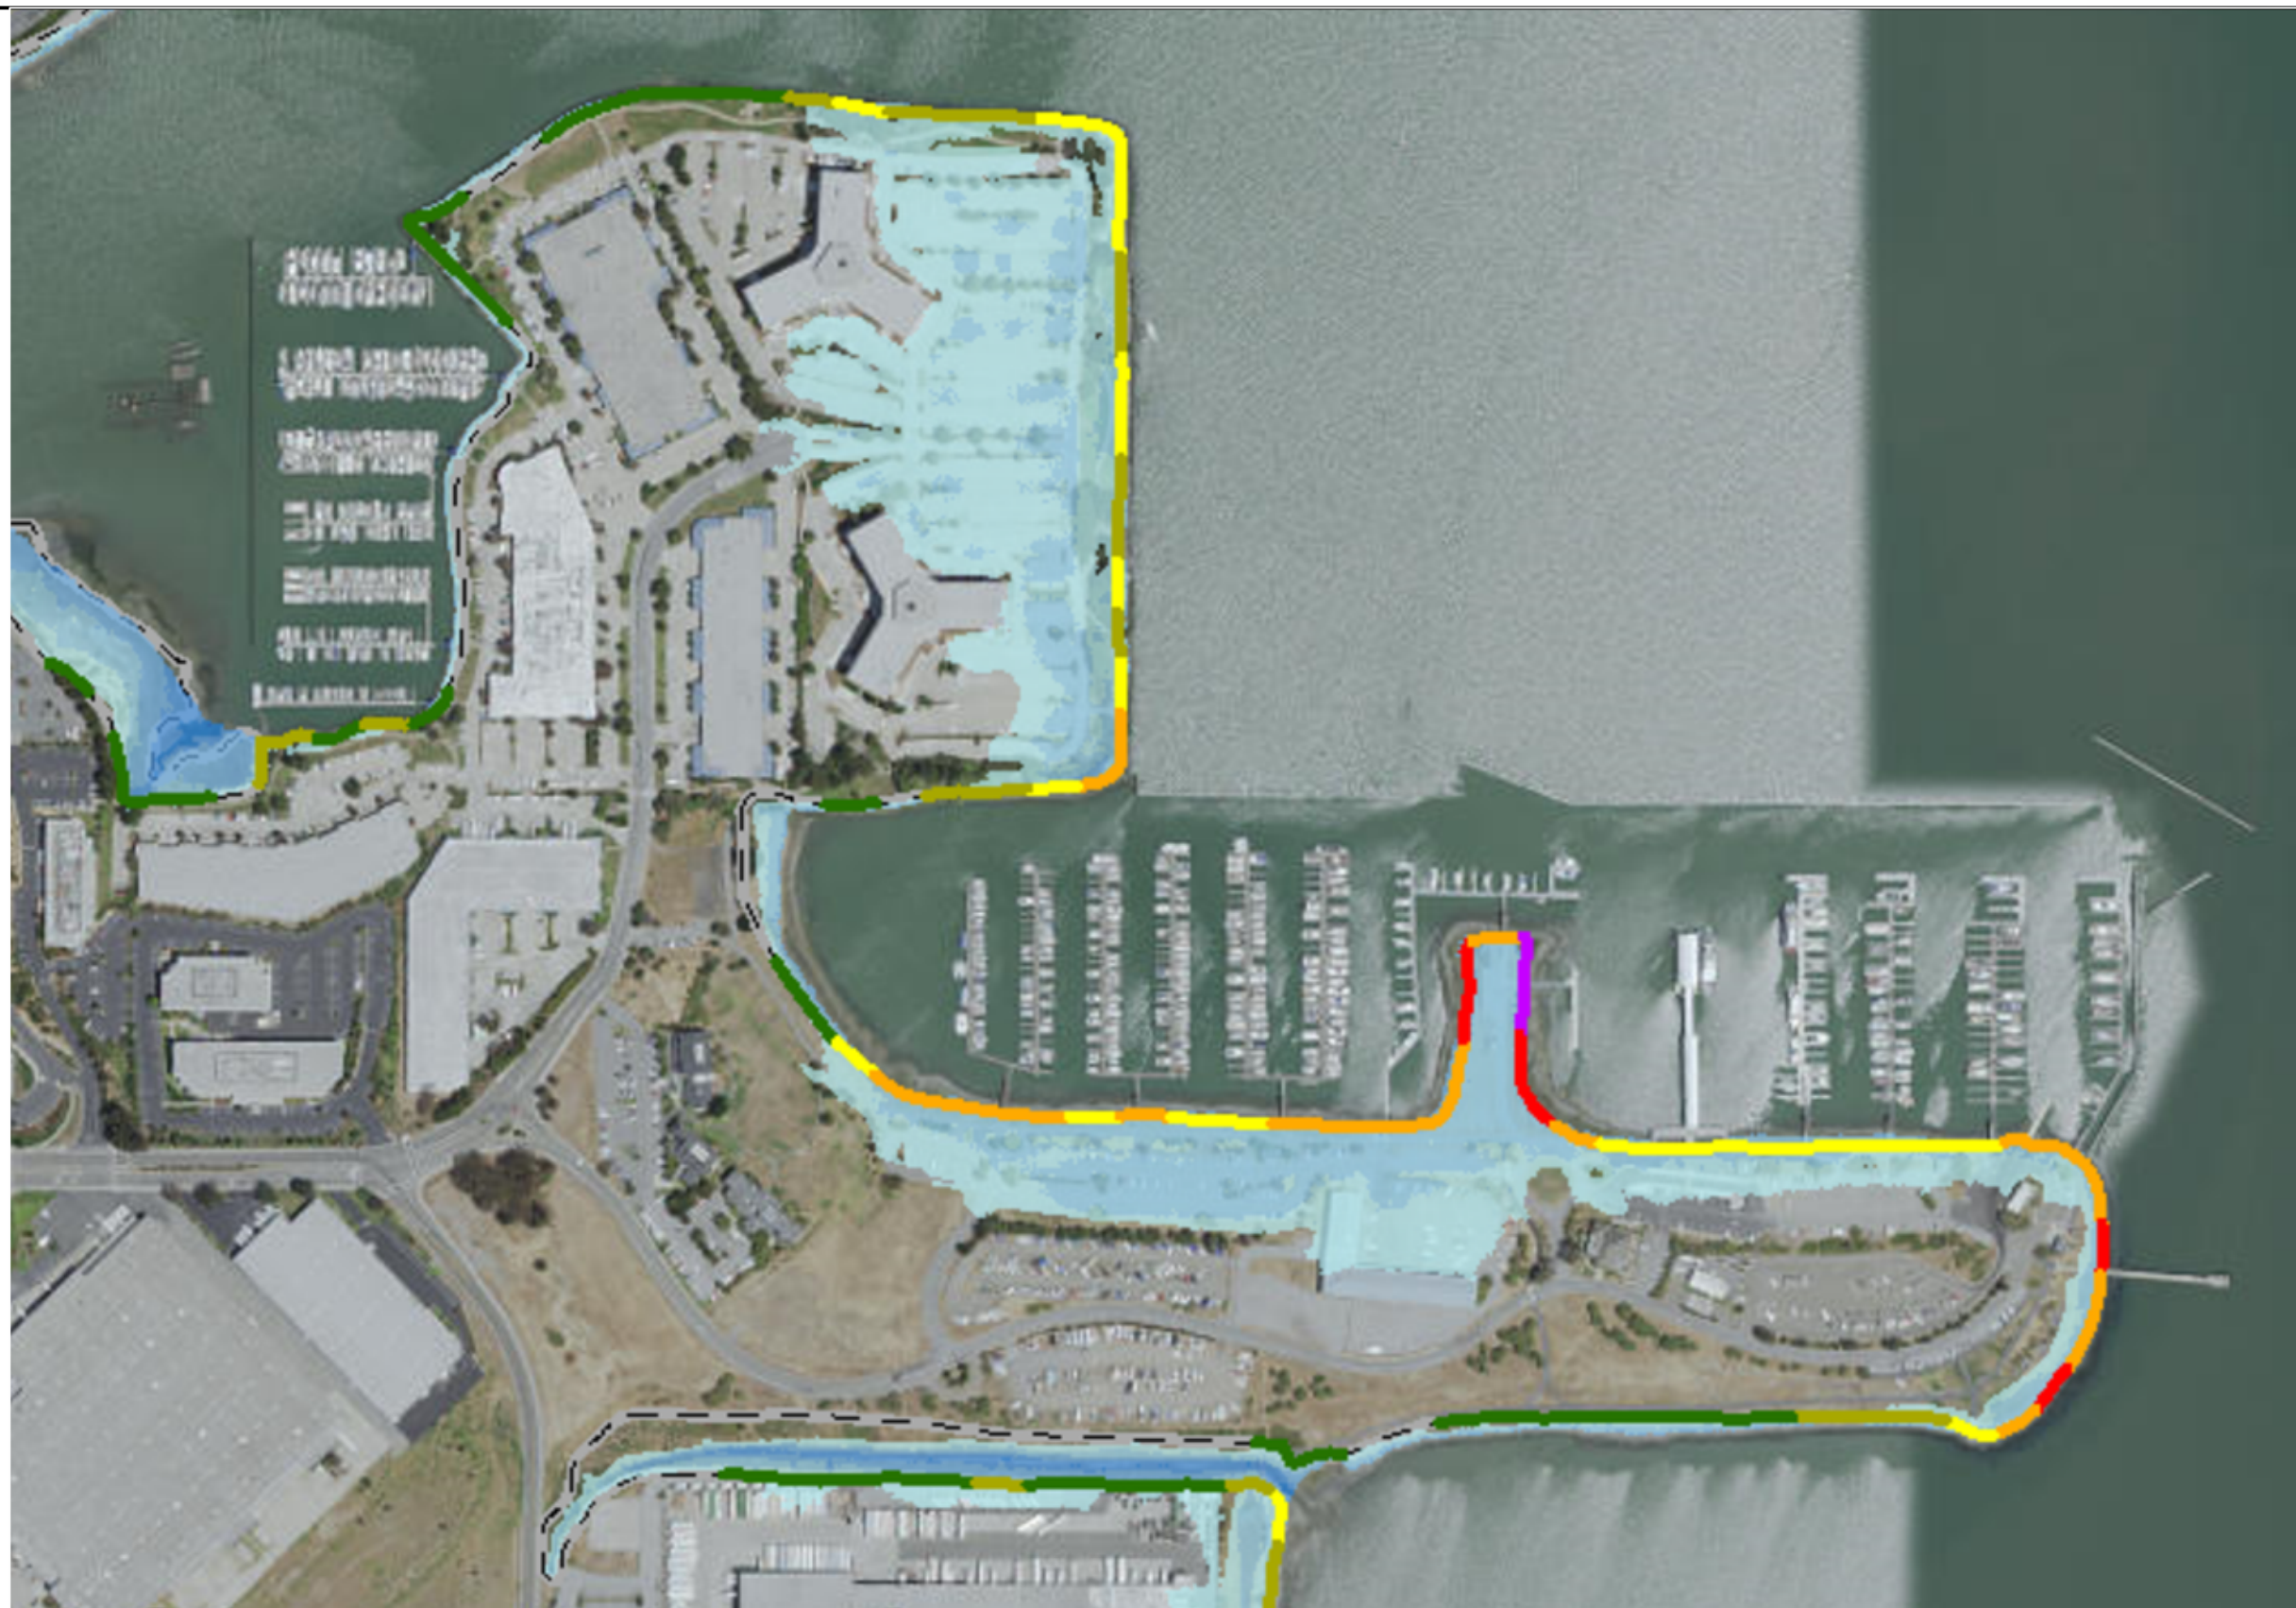
FIGURE 8

MHHW + 52" SLR
Shoreline
Overtopping
Potential Depth
(Feet)

MHHW + 52" Sea
Level Rise Depth
(Feet)

SITE INUNDATION IN 2050 + 100 YEAR FLOOD - 52" SEA LEVEL RISE

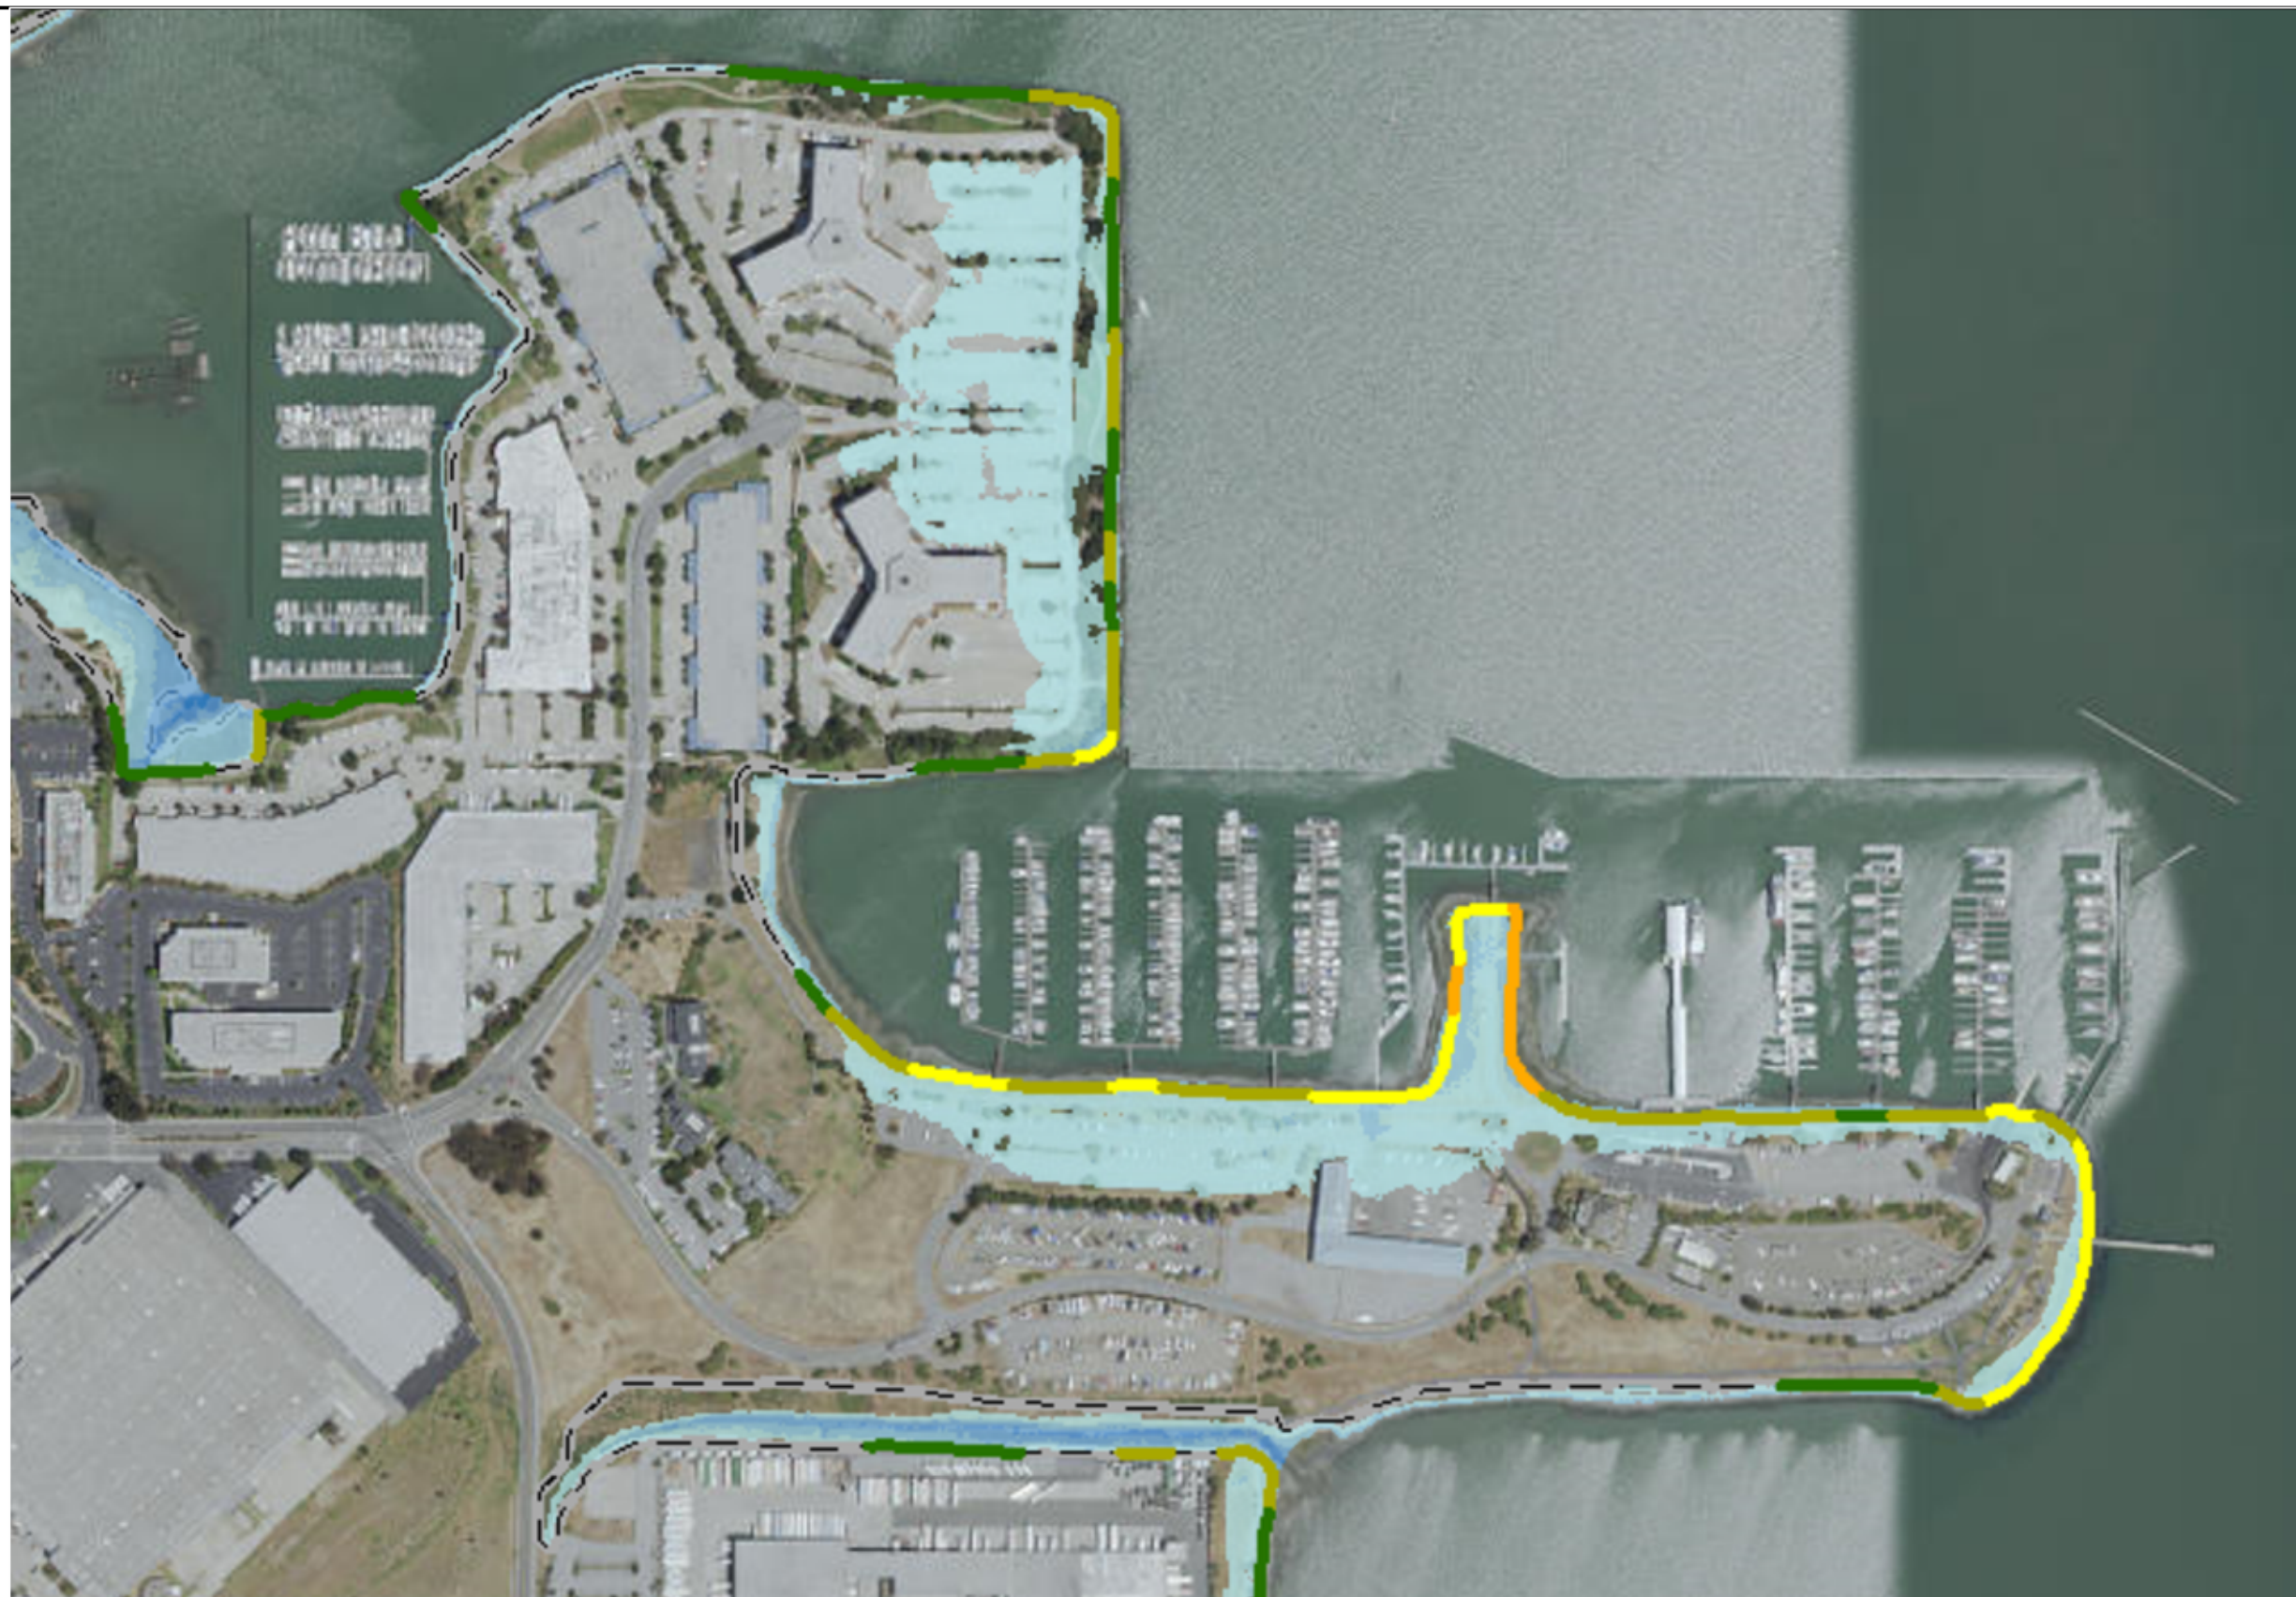
FIGURE 9

MHHW + 36" SLR
Shoreline
Overtopping
Potential Depth
(Feet)

MHHW + 36" Sea
Level Rise Depth
(Feet)

SITE INUNDATION IN 2100 - 36" SEA LEVEL RISE

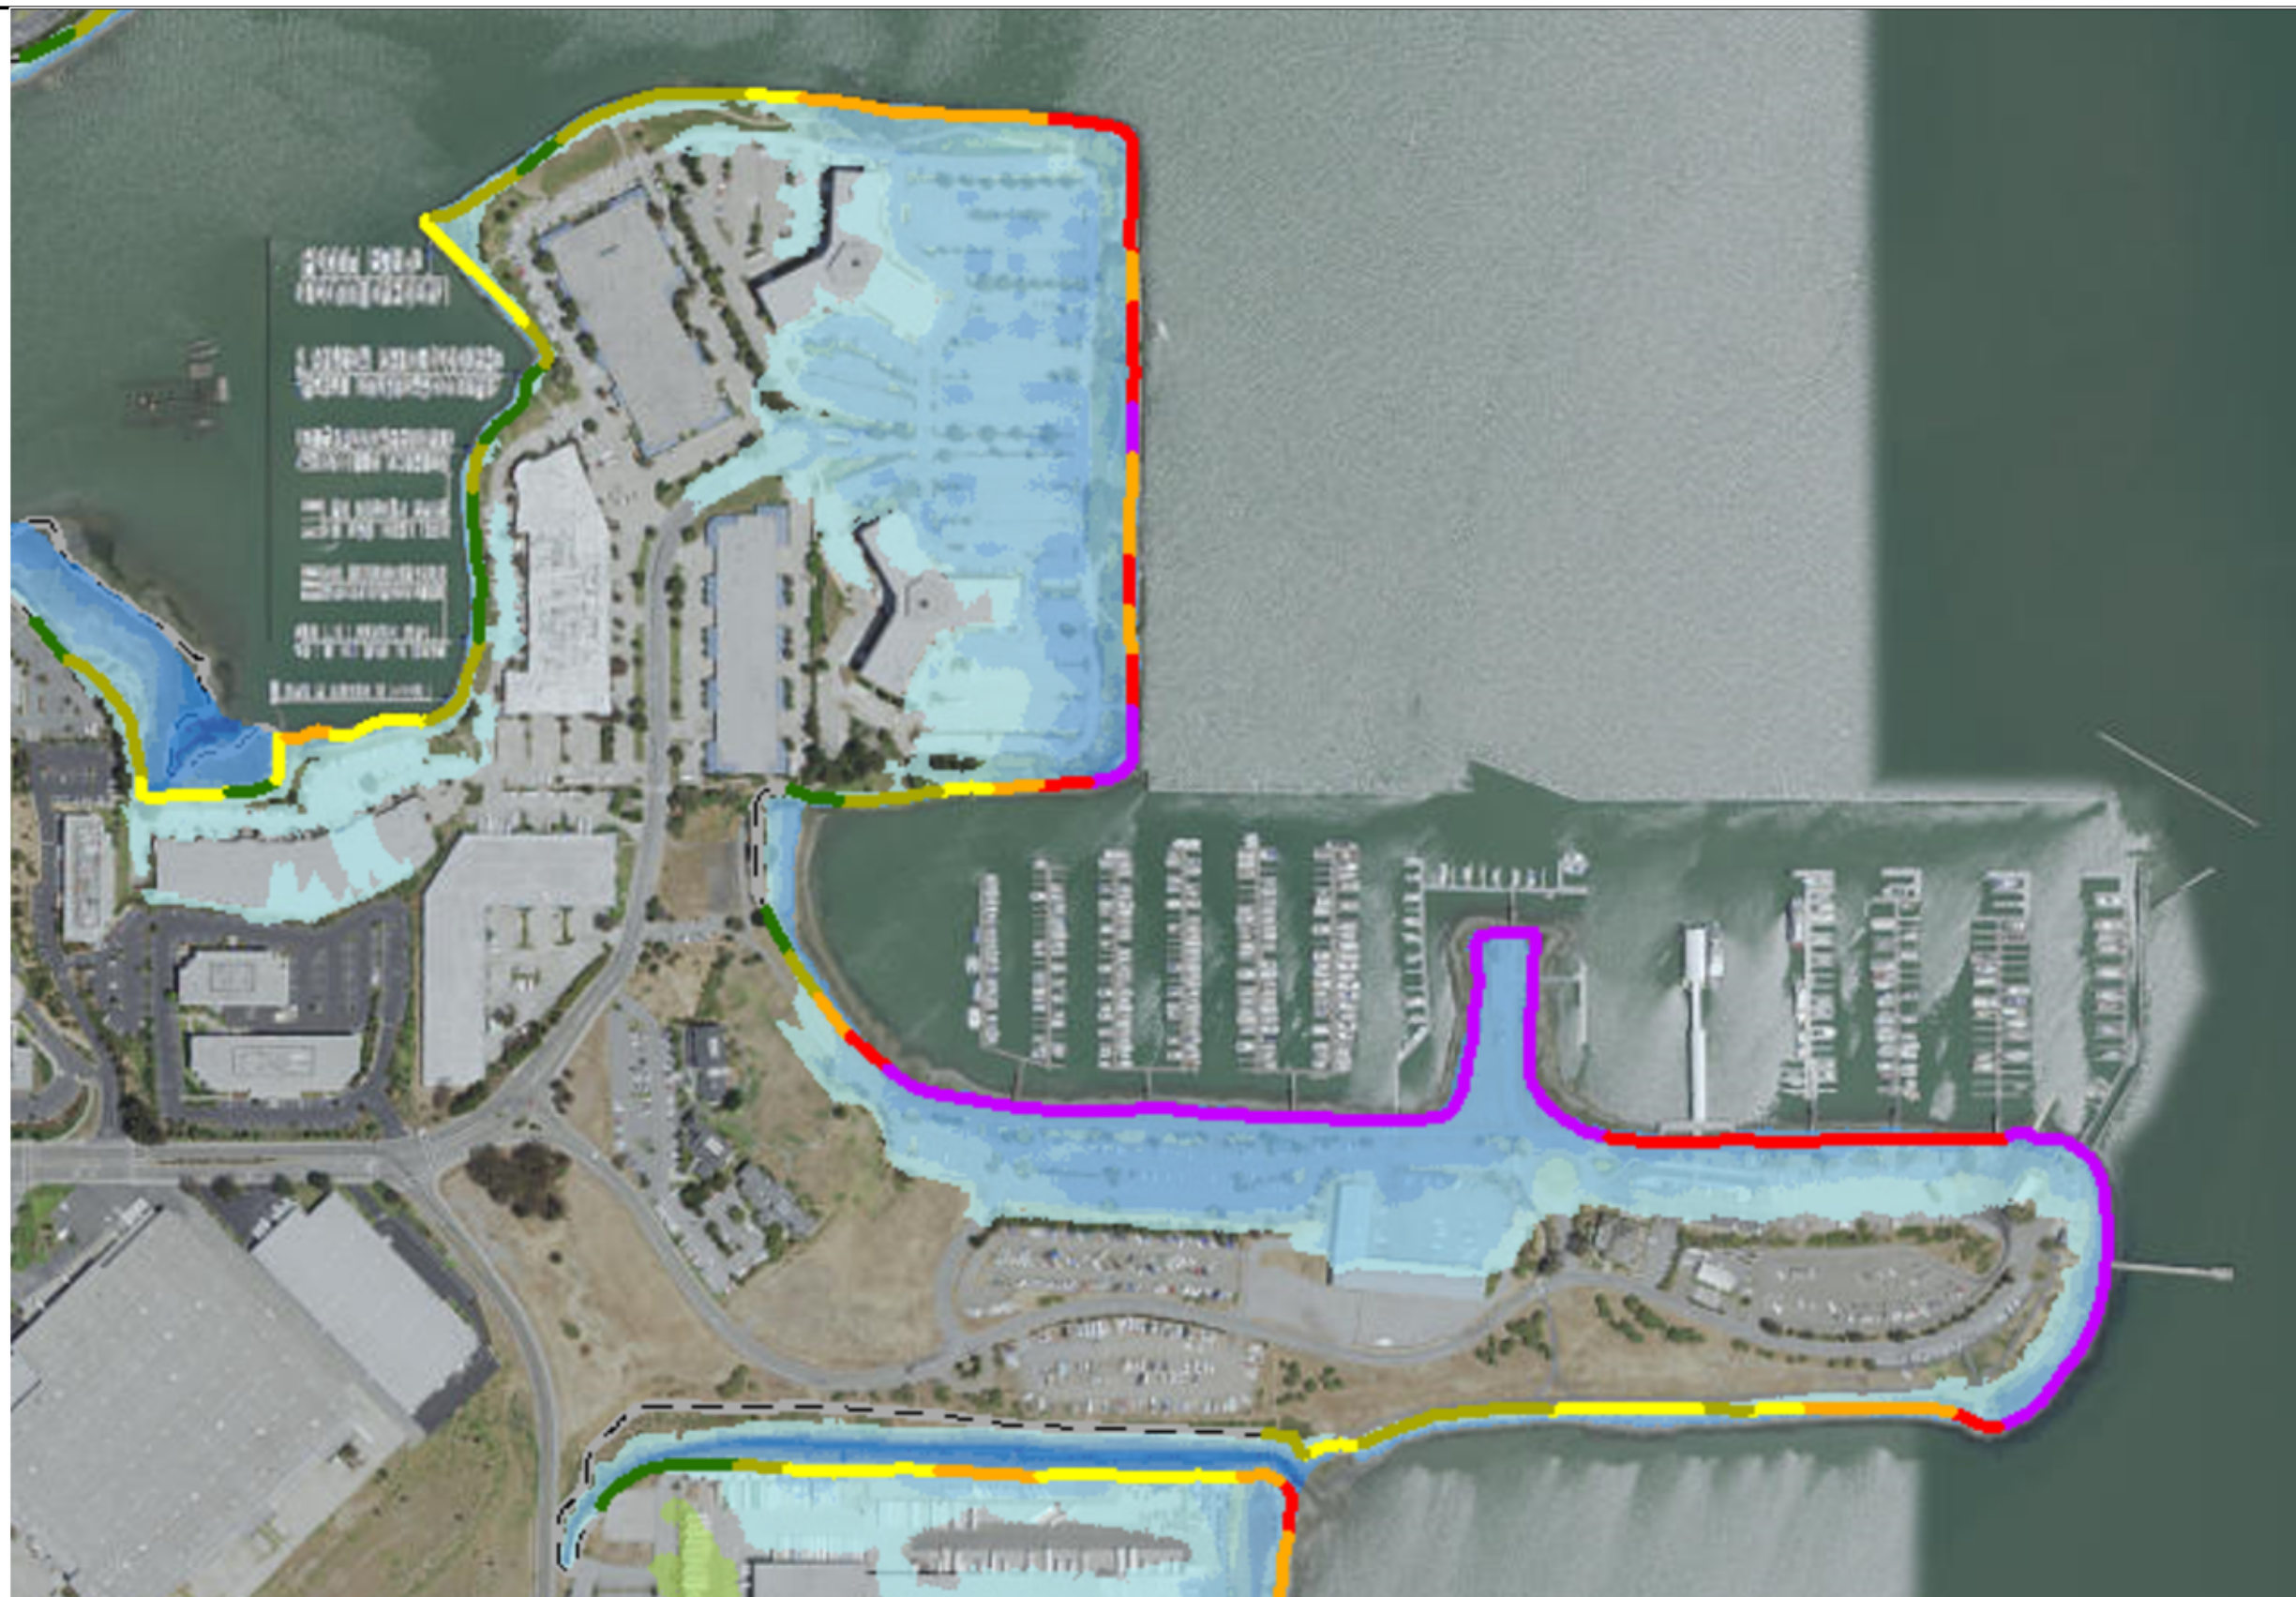
FIGURE 10

MHHW + 77" SLR
Shoreline
Overtopping
Potential Depth
(Feet)

MHHW + 77" Sea
Level Rise Depth
(Feet)

SITE INUNDATION IN 2100 + 100 YEAR FLOOD - 77" SEA LEVEL RISE
